09/06/85 Midwest Express Airlines, Inc.

Official Accident Report Index Page

Report Number	NTSB/AAR-87/01
Access Number	PB87-910401
Report Title	Midwest Express Airlines, Inc. DC-9-14, N100 ME, General Billy Mitchell Field, Milwaukee, Wisconsin, September 6, 1985
Report Date	February 3, 1987
Organization Name	National Transportation Safety Board Bureau of Accident Investigation Washington, D.C. 20594
WUN	4267-A
Sponsor Name	NATIONAL TRANSPORTATION SAFETY BOARD Washington, D. C. 20594
Report Type	Aircraft Accident Report September 6, 1985
Distribution Status	This document is available through the National Technical Information Service, Springfield, Virginia, 22161
Report Class	UNCLASSIFIED
Pg Class	UNCLASSIFIED
Pages	105
Keywords	removable sleeve spacer; high pressure compressor spacer; improper use of flight controls
Abstract	<p>At 1521 c.d.t. on September 6, 1985, Midwest Express Airlines, Inc., Flight 105, a McDonnell-Douglas DC-9-14 airplane, crashed into an open field at the edge of a wooded area about 1,680 feet southwest of the departure end of runway 19R shortly after taking off from General Billy Mitchell Field, Milwaukee, Wisconsin. The weather was clear with visibility 1

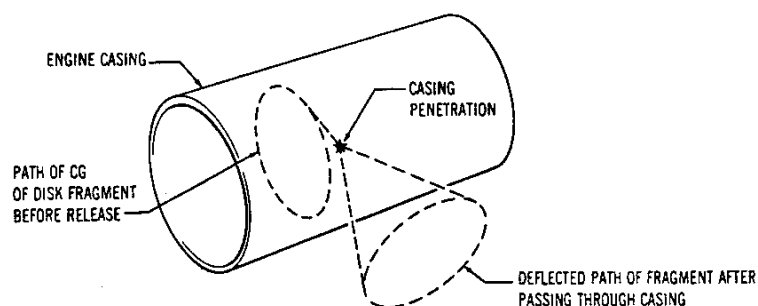
Figure 2.--Deflection path of uncontained engine parts.

Pratt & Whitney representatives testified at the public hearing that their experience had shown that the initial trajectory of uncontained rotating turbojet engine parts may be estimated by assuming that the parts (or fragments thereof) were initially ejected tangentially from their previous plane of rotation, through holes in the case and cowling. This is consistent with the aforementioned research findings. The initial trajectory path may be estimated by aligning a straight object, such as a broomstick, through the hole in the engine case from which the parts were ejected, to the outer diameter of the spacer or rotor that failed (the "broomstick" method). Pratt & Whitney reported that its previous service history of uncontained compressor spacer failures in JT8D-7 and JT8D-1 engines revealed that in incidents where the fuselage was penetrated by ejected spacer pieces, the holes in the fuselage were nearly directly in line with the penetrations of the engine case and tangent to the outer edge of the failed rotating part.

Using the broomstick method and relying on the Pratt & Whitney service experience, the initial trajectory of the ejected right engine spacer pieces was determined to be at an angle of about 20° to the right of vertical, away from the fuselage. Based on the calculated climb performance of N100ME (50 feet per second) before the right engine failed, the pitch attitude of the aircraft was determined to be 12° nose-up at the moment of the failure. The engines of the DC-9-14 were mounted to the engine pylons at another 3° nose up. Thus, the ejected engine parts were assumed to have a rearward component, based on the rearward alignment of the engine, 15° nose-up horizontal. A wind factor, based on a wind from 220° at 17 knots, was assumed.

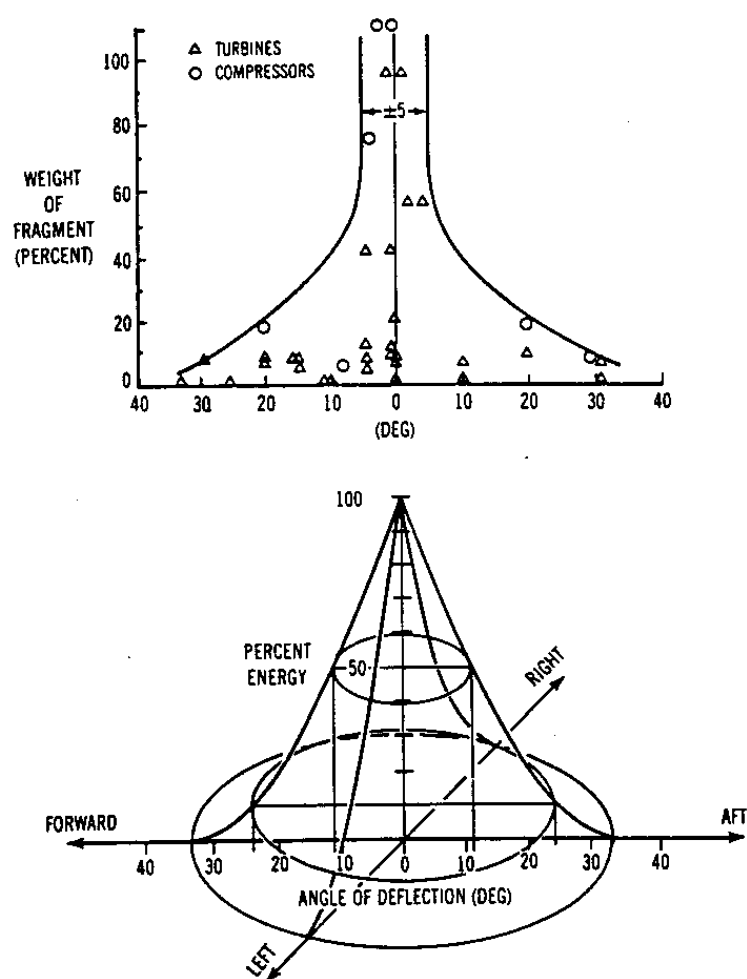
Figure 3.--Dispersion of uncontained engine parts.

The recovered spacer and compressor blade parts were measured to determine drag reference areas, using a factor of 0.635 [20](#) to allow for tumbling of parts. Thus, the drag reference areas for the largest spacer part, weighing 1.03 pounds; a smaller spacer part, weighing 0.07 pound; and a compressor blade piece, weighing 0.035 pound were determined to be 0.138, 0.03, and 0.019 square foot, respectively. A flat plate drag coefficient of 1.0 was assumed. For the purpose of determining potential tangential velocities, initial ejection speeds between 0 and 800 feet per second (fps) were considered. (Pratt & Whitney determined that the rim tangential velocity of the operating high pressure compressor

The heaviest part would have been most sensitive to the exit velocity and angle. The lighter parts would have been more sensitive to wind factors. It was found that the predicted central point of ground impact would have been about 400 feet rearward and 200 feet left of the aircraft at the time the parts were ejected from the right engine, assuming that the parts were ejected while the airplane was about 450 feet above the ground, left of the runway centerline and at 168 knots. The calculated ejection point was consistent with the point at which parts were determined to have been ejected, based upon the timing of the "clunk" on the CVR tape; the correlation of FDR, CVR, and recorded radar data; and the locations of the recovered engine parts.

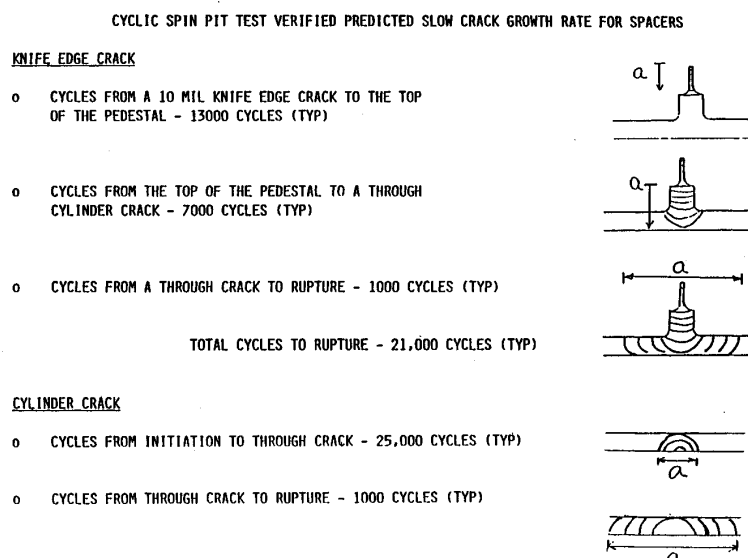
Figure 4.--Cyclic spin test results.

The cyclic spin test indicated that a 10-mil crack originating in the cylinder wall typically required 25,000 cycles to become a cylinder-through-crack, and then another 1,000 cycles to rupture. (Pratt & Whitney cyclic spin test results are shown [in figure 4.](#)) In each example, a 10-mil crack was assumed as the initiating crack length.

Pratt & Whitney reported that the growth of spacer knife-edge cracks is retarded when the cracks begin to propagate into larger cross sections. The spin test showed that about 3,000 cycles are needed to propagate a knife-edge crack from the thin knife edge to the thicker pedestal section of a compressor spacer.

Based upon an analytical model developed from the 1980 cyclic spin pit data, Pratt & Whitney concluded that, at approximately 3,000 test cycles before (imminent) rupture of a 7-8 stage spacer, a fatigue crack initiating in a knife edge would have extended to a length of at least 0.20 inch. A crack of this size would extend through the knife edge and into the pedestal in either the 7-8 or 9-10 stage spacer. Pratt & Whitney calculated a crack growth rate equation for a 9-10 stage spacer based on the 7-8 stage data and the known differences in operating temperatures and stress. The calculation indicated that a knife edge crack would be 0.33 inch in length about 3,000 (test) cycles before rupture of the 9-10 stage spacer.

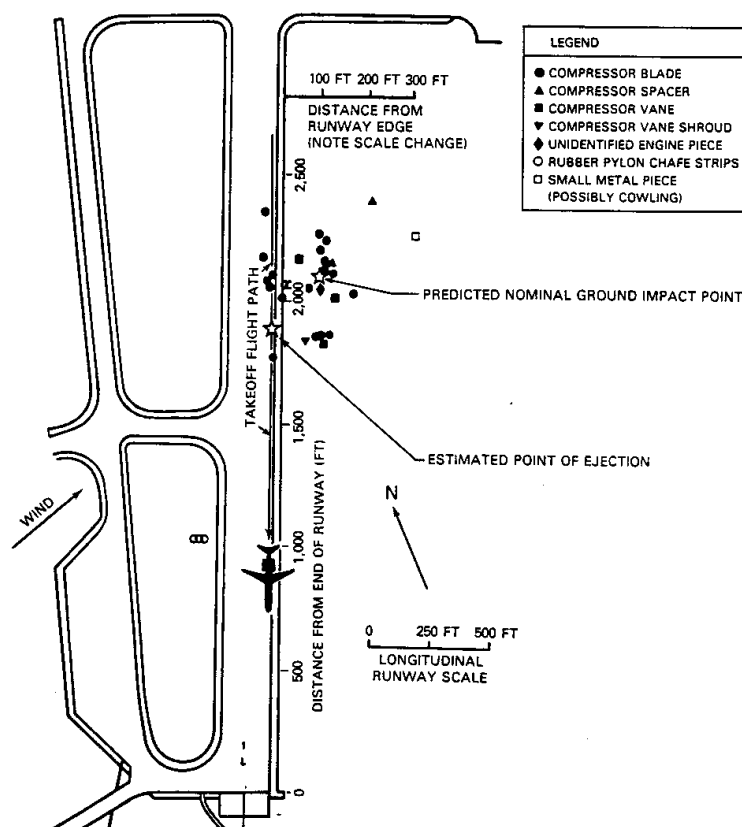
Figure 6. --Calculated nominal ground impact point and actual locations of engine debris adjacent to runway 19R.

Calculations showed that, from the point at which spacer parts were actually ejected from the right engine, the distribution of the parts found near runway 19R was as predicted for undeflected parts existing the right engine. (See [figure 6.](#)) The ejection paths of a few spacer pieces and compressor blades pieces could not be resolved because those parts were not found. However, based on the paths of the recovered debris, the Safety Board concludes that part of the spacer was probably ground into tiny, harmless pieces during the rupture and that part of the unaccounted for spacer pieces and blades might have been missed, despite a thorough search for engine debris in the grass adjacent to the runway.

Calculations showed that the deflection of engine parts by the engine casing or cowling would have resulted in the absorption of energy of the deflected parts, thereby reducing the velocity substantially and limiting the potential to produce any damage of consequence to the fuselage or to the control systems. For example, engine containment tests have shown that ejected engine debris which is deflected more than 33° loses virtually all of its energy.

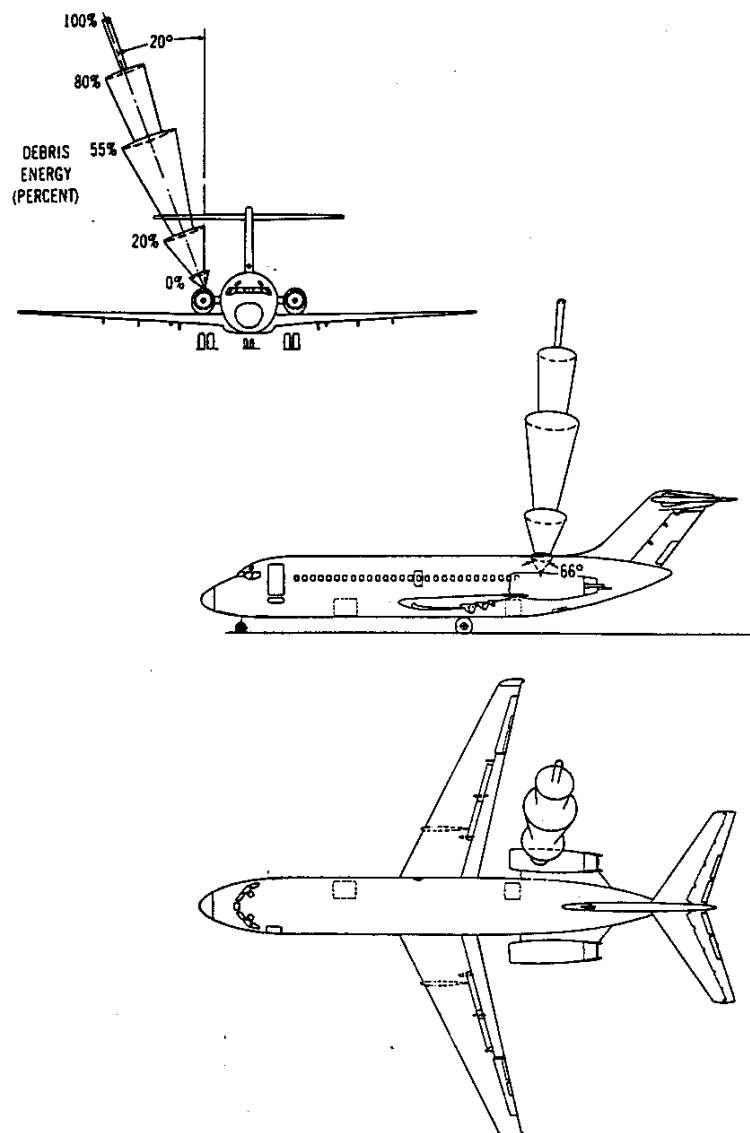
Figure 7.--Three-view drawing of a DC-9 series 10 airplane with various debris patterns and corresponding percentage of energy loss.

Figure 7 shows that undeflected parts are initially ejected in a direction approximated by the broomstick method; in this case, 20° outboard of vertical (away from the airplane fuselage) with high energy and speed. To have struck the Midwest Express fuselage, the parts would have had to have been deflected in excess of 65° and thus virtually all energy would have been lost.

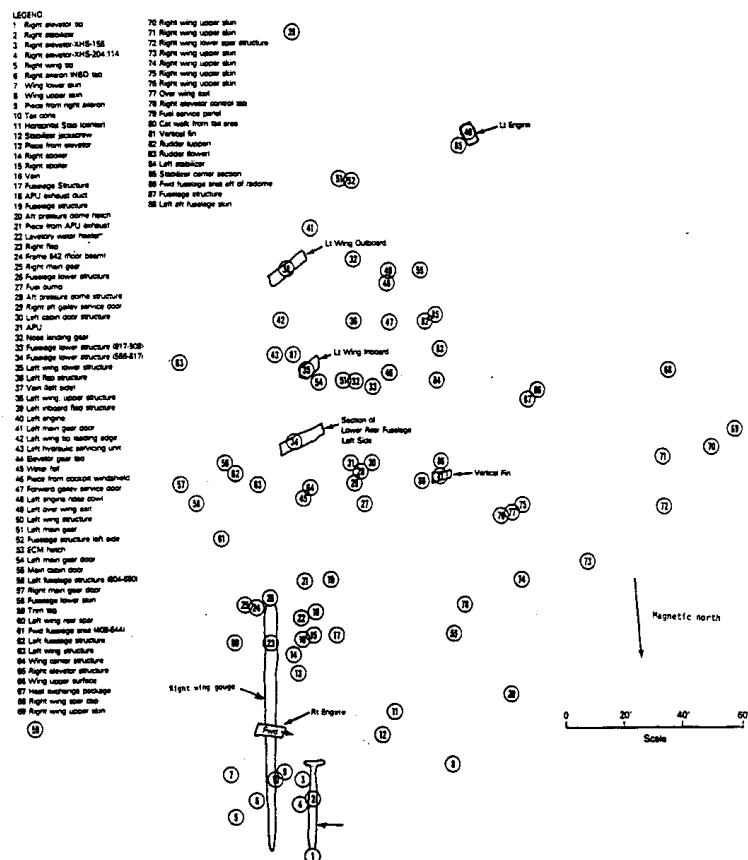
Appendix D Wreckage Diagram

Engine-related parts from the right engine were found up to 200 feet to the left side and between 7,400 and 8,200 feet south of the north end of runway 19R. The parts included compressor blades from the 9th and 10th stages of a Pratt & Whitney JT8D engine and parts, which totaled 90 percent, by weight, of a 9th to 10th stage (9-10) high pressure compressor spacer. With the exception of the engine-related parts found on and adjacent to runway 19R, the wreckage of N100ME was recovered from the airplane impact area. (See appendix D.)
